Title: Multi-Site Fatigue Testing and Characterization of Fuselage Panels from Aging Aircraft Structure

Multi-Site Fatigue Testing and Characterization of Fuselage Panels from Aging Aircraft Structure

Sandeep R. Shah¹, Todd B. St John¹, Ian L. Pryce, Jr.¹,
Gregory A. Shoales² and James M. Greer, Jr.²

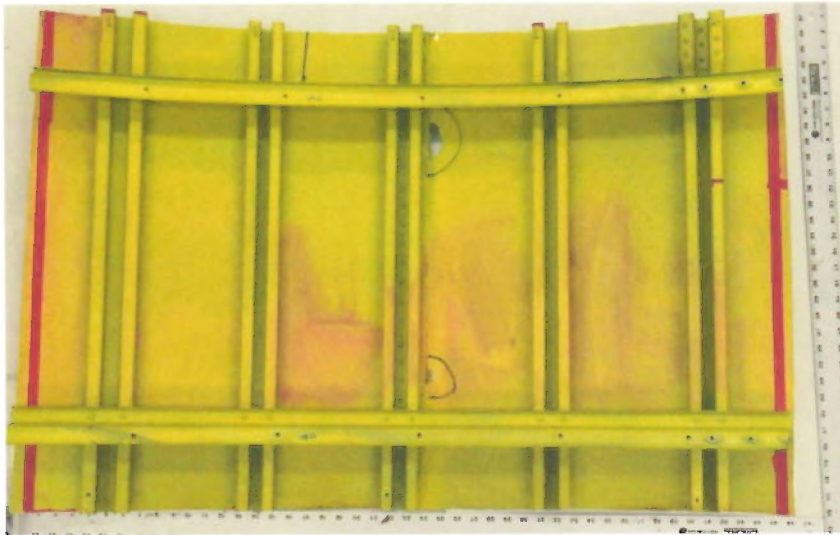
Figure 1: Photo showing as-removed section for the residual life testing (scales in inches).

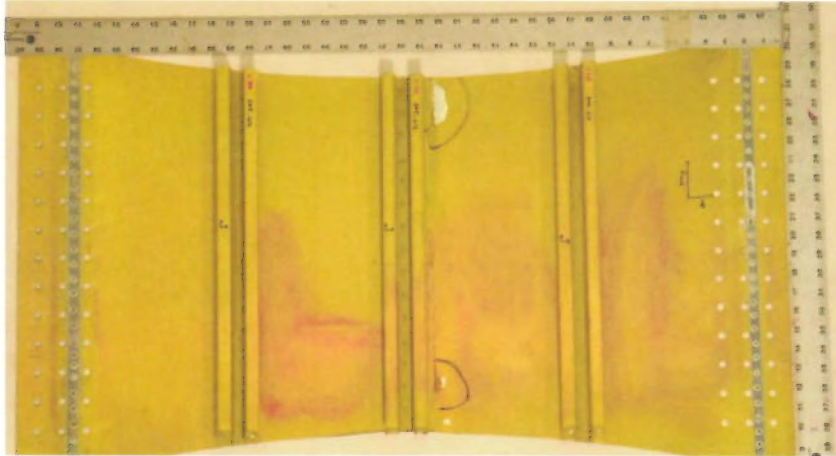
Figure 2: Photo showing the prepared test specimen after machining from the received section of Figure 1 (scales in inches).

The fasteners at the edges of the panel were replaced with next-oversize fasteners with a slight interference fit to prevent crack initiation from edge fasteners. The machined specimen was then instrumented with strain gages. Five strain gages were applied just above the lap joint and five were applied just below the lap joint. They were equally spaced along the width of the specimen and measured the strain in the two skin panels of the lap joint. The specimen was then gripped in steel grips with 3/8 in SAE grade 8 bolts and nuts. These steel grips gradually tapered to 125 mm (5 in) or 150 mm (6 in) tabs, which were gripped in either 500,000 N (110 kip) or 1,000,000 N (220 kip) capacity servo-hydraulic test frame (MTS – Eden Prairie, MN, USA) respectively. The test specimen assembled in the grips was then mounted in the test frame, with tabs of the grips held in the hydraulic wedge assembly of the test frame as shown in Figure 3. The strain gages were monitored using a separate data acquisition computer running LabView from National Instruments (Austin, TX). The load and displacement of the ram were monitored by the control computer of the test frame. The proportional analog output was taken from the machine's controller and fed to the LabView computer for storage.
